EARTHEN HERITAGE DIAGNOSIS

French Embassy in Ghana | FSPI Sankofa

Sebastien Moriset, CRAterre | December 2021

CRAterre project code GHA031

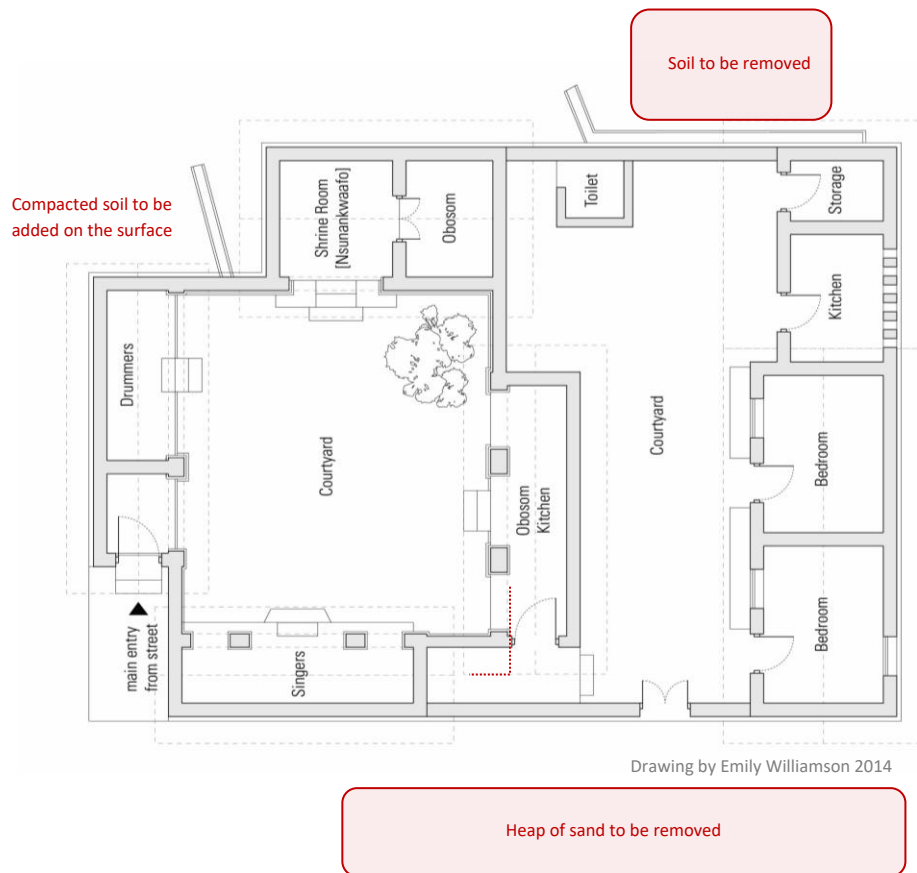
A well-preserved shrine which is only lacking a priest(ess) to be fully alive

- Marking the site boundaries with a visually non-intrusive fence (shrubs fence for example) to avoid encroachment
- Discuss with the community to ensure that no encroachment will take place.
- Work with the town planning authorities to ensure that no storey building will be allowed in a 500 m radius.

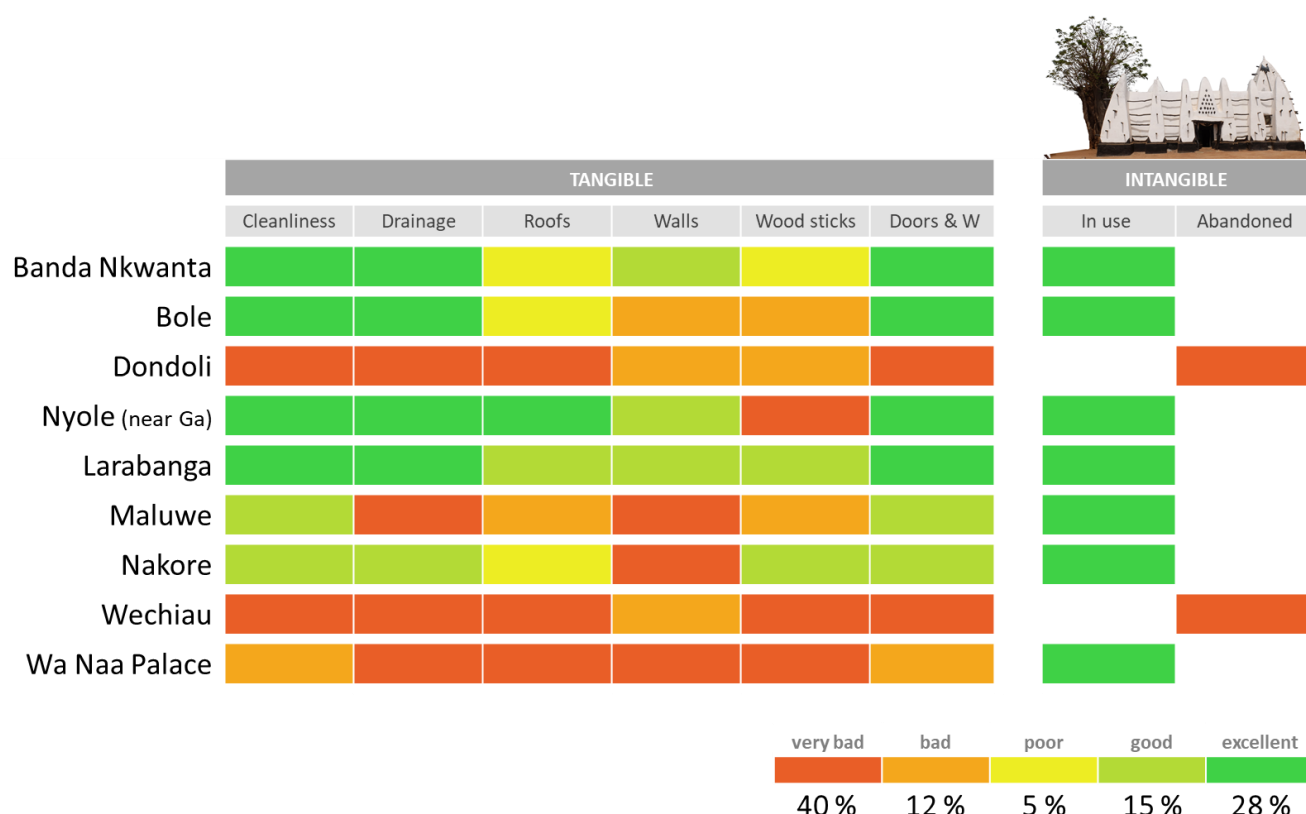
State of conservation of the 8 Ancient mosques and Wa Naa Palace

This table shows that the situation is unfortunately alarming. More than half of the buildings visited are in poor condition and two mosques are abandoned (Dondoli and Wechiau). The other mosques are still in use but two (Maluwe and Nakore) are weakened by their thick waterproof cement plaster. The Wa Naa Palace is still in use but has undergone profound and totally irreversible architectural transformations.

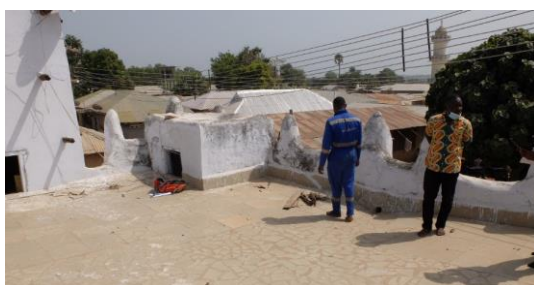
Mirhab reconstructed with cement blocks

Impressive and well-maintained mosque, although it is being modified. The interior has been tiled and the mirhab is no longer made of earth bricks but of cement blocks.

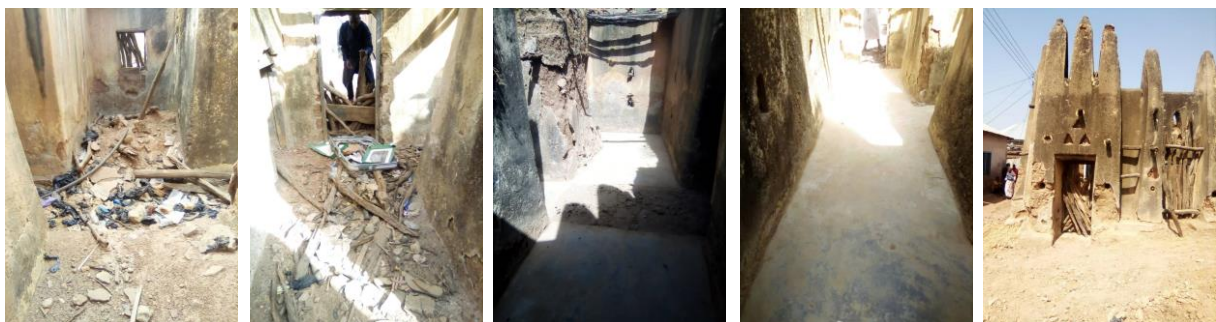
Removal of the rubbish and work on the drainage in December 2021 (photos by Kenneth Fomjegeba)

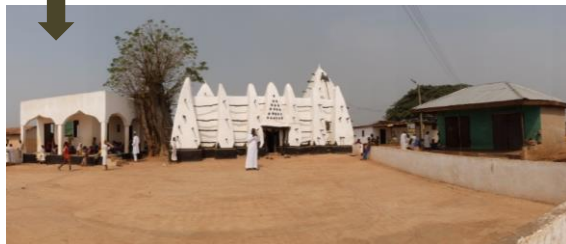
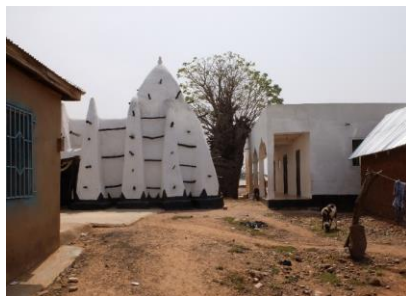
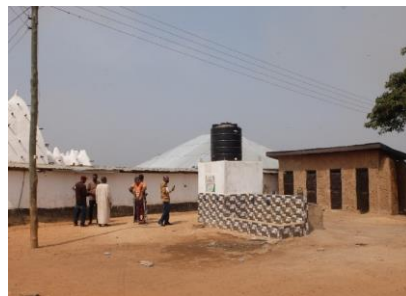
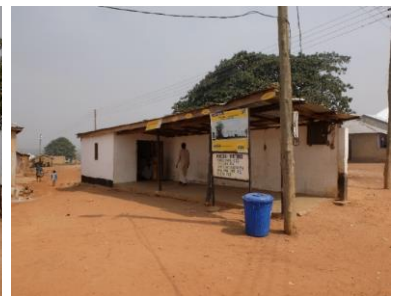
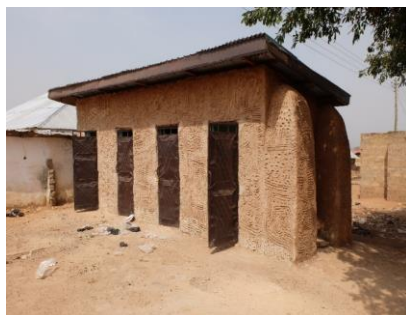
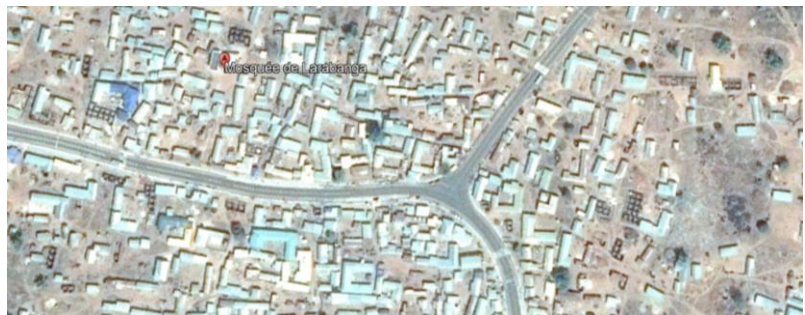
A new women's mosque, toilets, a cemented esplanade, a boundary wall, a visitors' office, most village houses covered with corrugated iron roofs, etc. Larabanga is evolving very quickly.

- Work with the community on a management plan
- Demolish the cement mosque and relocate it at least 10 meters away from the old mosque

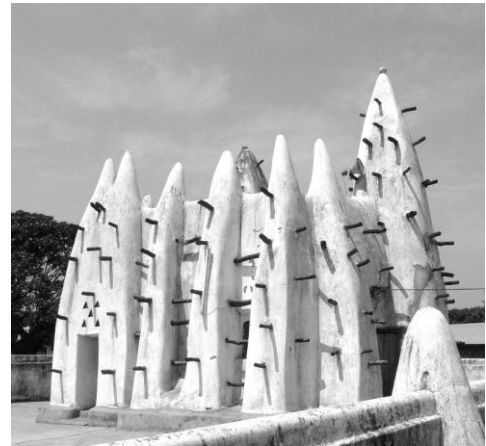
2009 image showing the previous shape of the mirhab

- Reconstruction of the top of the mihrab with the right shape
- Removing the garbage
- Planting trees to avoid encroachment

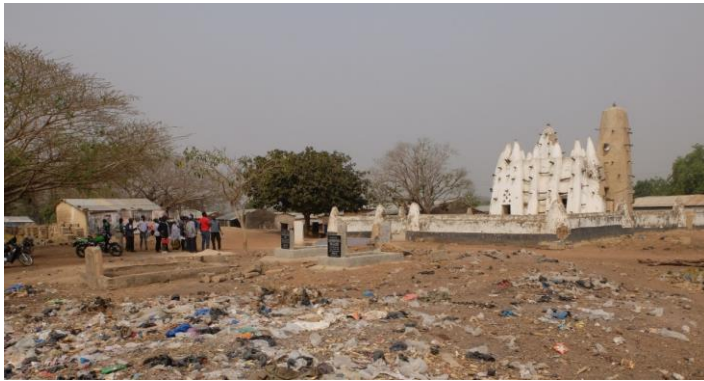
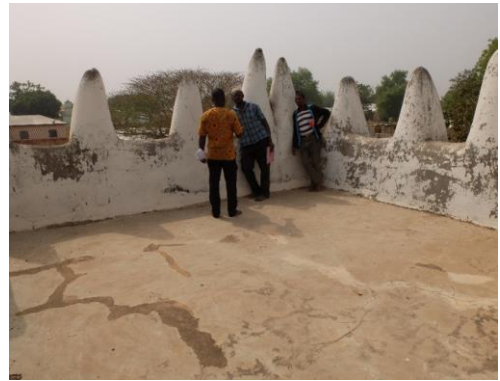
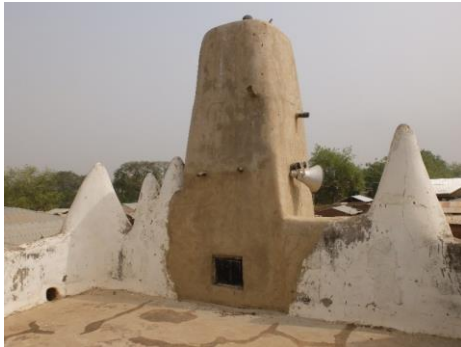
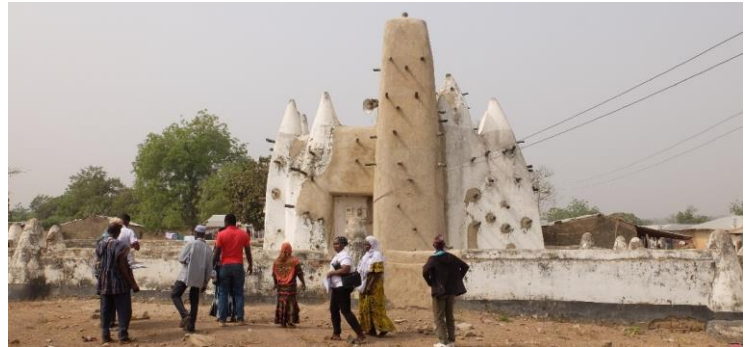
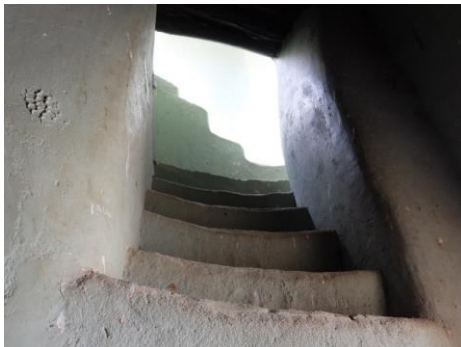
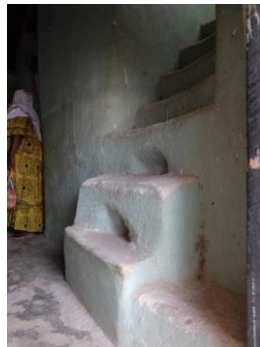
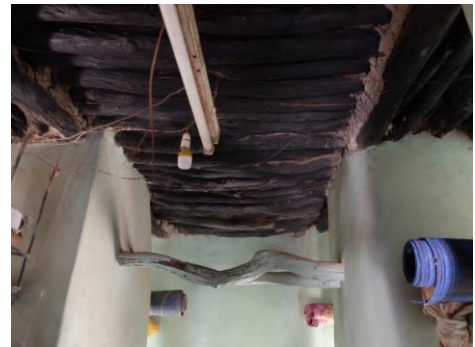
Mosque regularly maintained by its community but whose mirhab unfortunately collapsed in 2017 and was badly rebuilt this year with the wrong shape using cement blocks

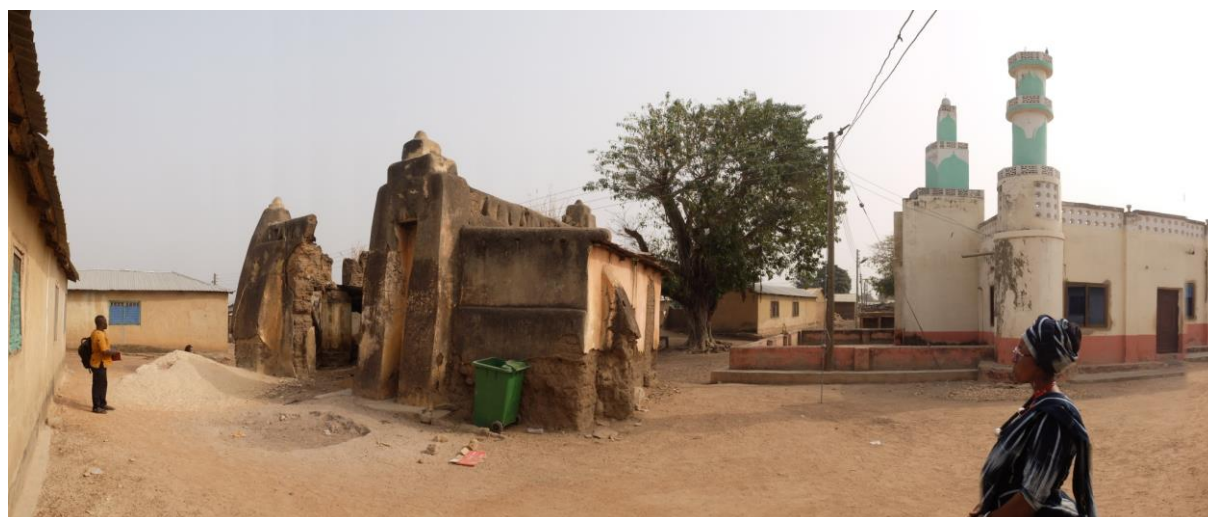
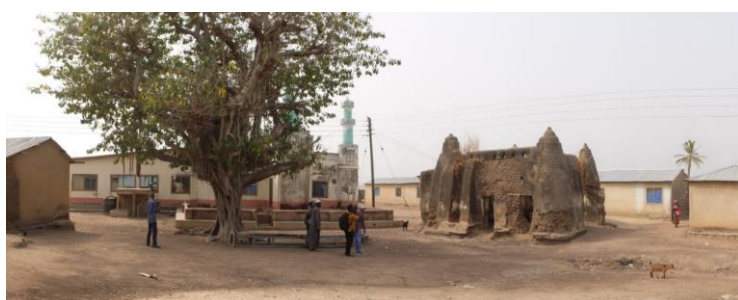
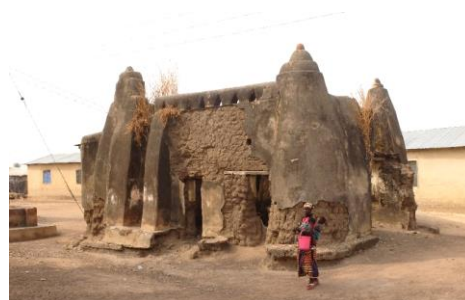
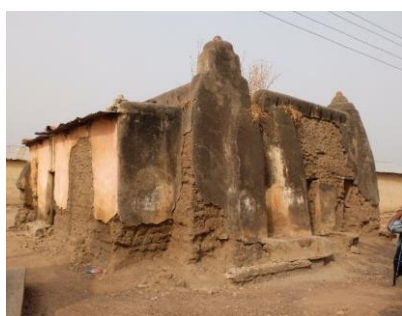
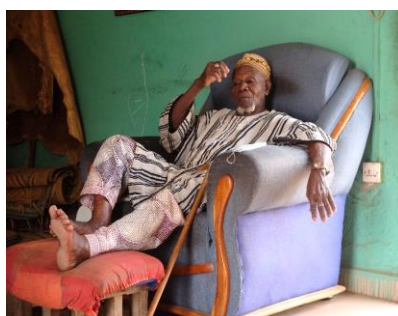
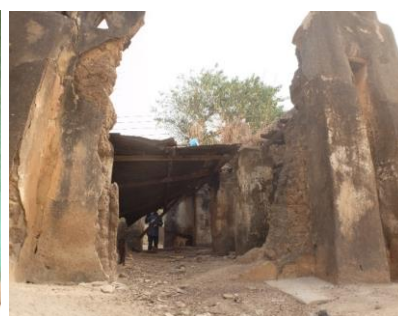
Remains of the Wechiau Mosque, whose architecture differs from the other mosques visited

- Clean the ruins to avoid water stagnation
- Document the remains
- Sensitive the community on the importance of safeguarding the property
- Source funds for complete restoration

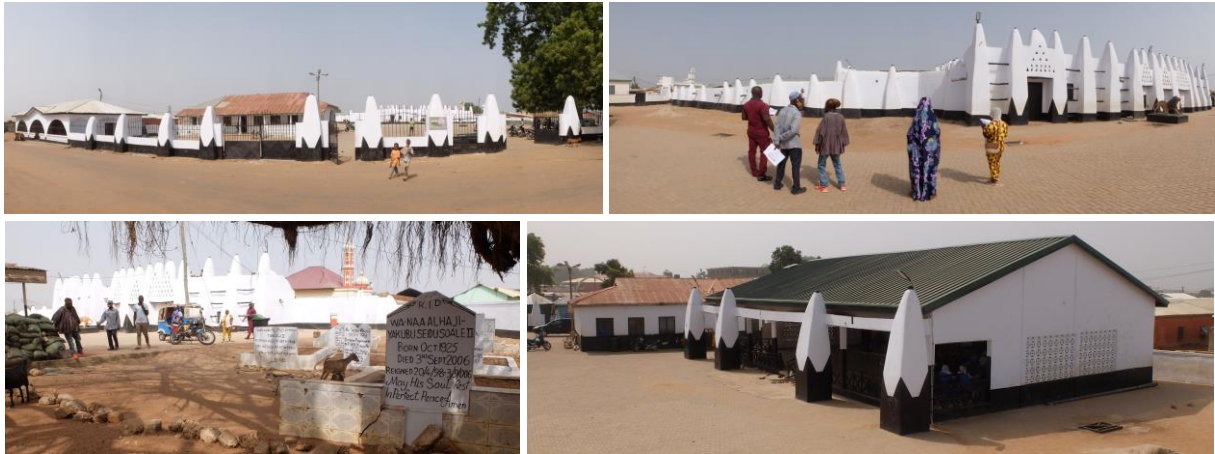
The Wa Naa Palace gives an excellent impression from the outside, with its redesigned and very neat forecourt, but it is only a ceremonial façade. The façade has been partly rebuilt with cement block pinnacles. The rear part is unfortunately completely destroyed. Out of the 42 organically shaped rooms appearing on the 1980 plan, only 8 still have their earthen terrace roofs. All the others have been either destroyed or replaced by completely different buildings, all made of cement blocks and covered with corrugated iron roofs. A mosque has even been built in the palace itself. There is nothing left from the Wa Naa Palace to show to any visitor apart from this façade which, despite the new materials used for some of the pinnacles, is still very impressive.

The esplanade in front of the courtyard has been paved. The facade is really well enhanced and the esplanade is protected from encroachment by a surrounding wall. The first impression on arriving at the site is overwhelming. The only striking feature is a protruding minaret behind this façade. It is the minaret of a new mosque that has been built in the palace grounds.

- Reinforce collaboration between the custodians and GMMB technicians to share decisions.
- Widen the water channel between the inner courtyard and the esplanade
- Replace wooden window shutters
- Develop a management plan based on a clear vision for this site. Should it just be an wide esplanade with an impressive Palace elevation at the back ? Should it be a real Palace again where the chief can display the culture of his Chiefdom ? Should it be a tourist attraction ?
- Identify immovable/movable elements that can be conserved.
